CERTAIN COMMERCIAL-APPLICATION MX775V, MX800V, MX825V MODELS

Oil Cooler Leaks Due to Hoses Out of Tolerance

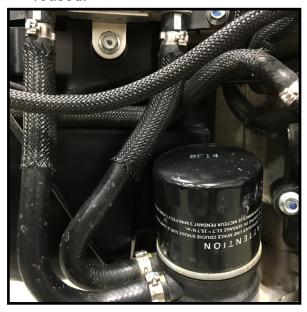
- 1. Removing the Oil Cooler Assembly
- 1.1 Remove the oil filter. The oil filter will be reused.

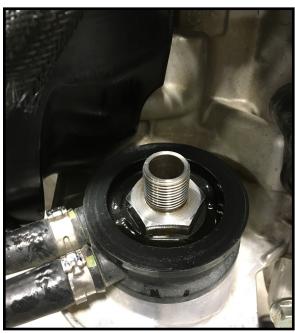
1.3 Remove the oil filter adapter union bolt and the oil cooler adapter. The union bolt will be reused.

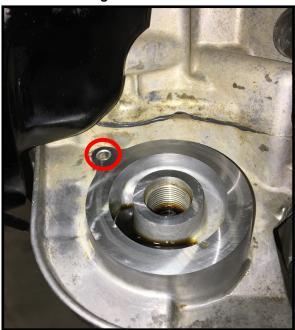
1.4 Clean the crankcase cover 2 mating surface. NOTE: The oil filter adapter locating pin aligns with the crankcase cover 2 alignment hole shown.

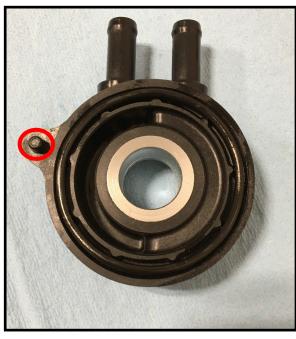
2.1 Lubricate the new seal (O-ring) from the kit with oil and install the oil filter adapter. NOTE: The oil filter adapter locating pin shown aligns with the crankcase cover 2 alignment hole.

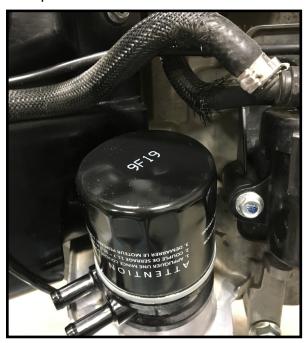
Adapter union bolt: 62 N·m (6.2 kgf·m, 45 lb·ft) 2.3 Install the oil filter and tighten to specification.

14 N⋅m (1.4 kgf⋅m, 10 lb⋅ft)

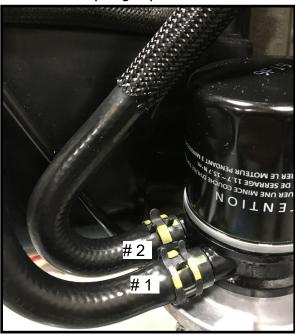
2.4 Install the new oil hose 1 and 2 from the kit onto the oil filter adapter using the new spring clips. NOTE: *Position the new spring clips as shown.*

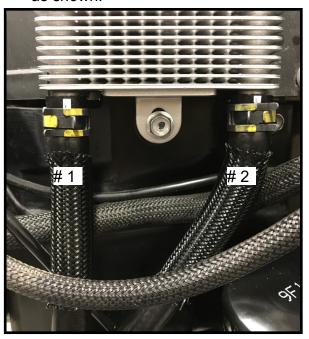
2.5 Install oil cooler hose 1 and 2 onto the oil cooler assembly using spring clips. NOTE: Position the new spring clips as shown.
